Manhole Inspection Summary

Manhole # S45GG_071MH

Insp Date: **8/14/08 12:29 PM**

Location Address: **Wolfe**

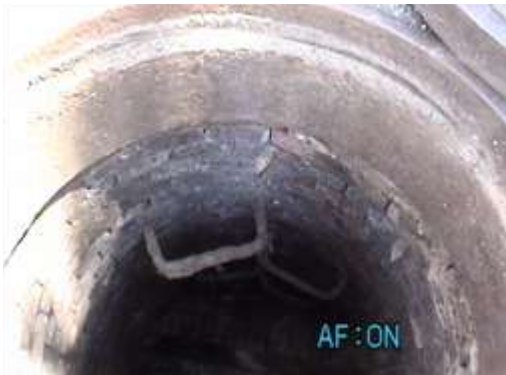
Defect 2

Infiltration: ☐ None ☐ Joint ☐ Cracks ☐ Mortar ☐ Roots ☒ **Wall**

Infiltration

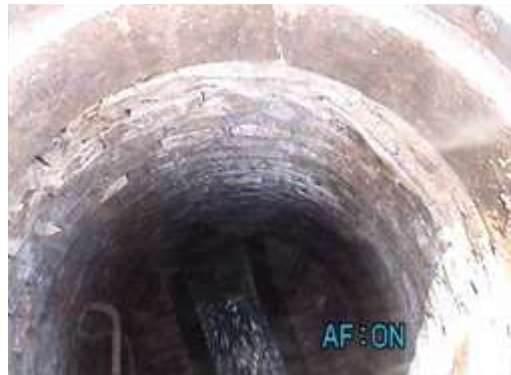
Defect 1

Condition: ☐ Sound ☐ Cracked ☐ Root Intrusion ☒ **Loose Brick** ☐ Deteriorated

Infiltration: ☐ None ☐ Joint ☐ Cracks ☒ **Mortar** ☐ Roots ☐ Wall

loose brick

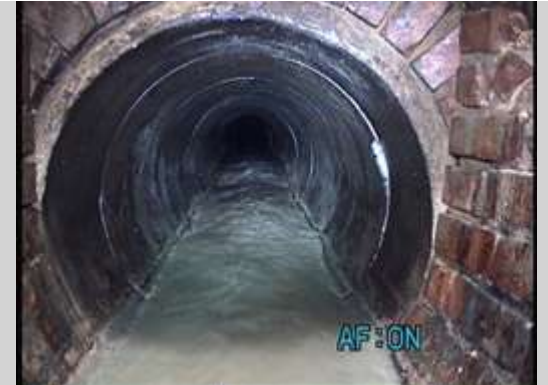
12 O'Clock Outflow

22 in. Circular Gravity Sewer
Pipe Out @ 12 O'Clock

Pipe Height: **21.6** (in.) Rod and Bar (Angled)
Pipe Material: **Clay** ☐ Pipe Lined
Invert Depth: **12.00** (ft.) Flow Characteristics: **Fast**
Deposits: ☒ None ☐ Mud ☐ Sludge ☐ Debris ☐ Grease
Silt Depth: (in.) Deposits Extent:
Infiltration: **None** Pipe Seal Cond: **Sound**

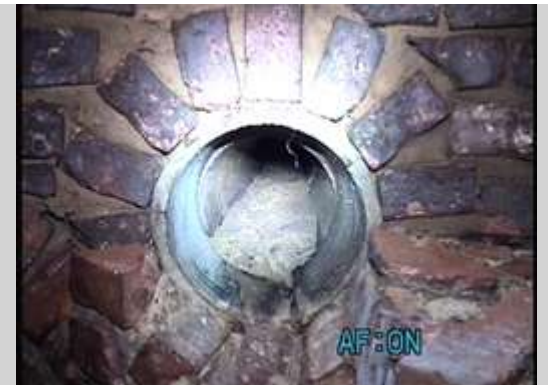
2 O'Clock Inflow

8 in. Circular Gravity Sewer
Pipe In @ 2 O'Clock

Pipe Height: **8.4** (in.) Rod and Bar (Angled)
Pipe Material: **Clay** ☐ Pipe Lined
Invert Depth: **10.50** (ft.) Flow Characteristics: **Fast**
Deposits: ☒ None ☐ Mud ☐ Sludge ☐ Debris ☐ Grease
Silt Depth: (in.) Deposits Extent:
Infiltration: **None** Pipe Seal Cond: **Sound**

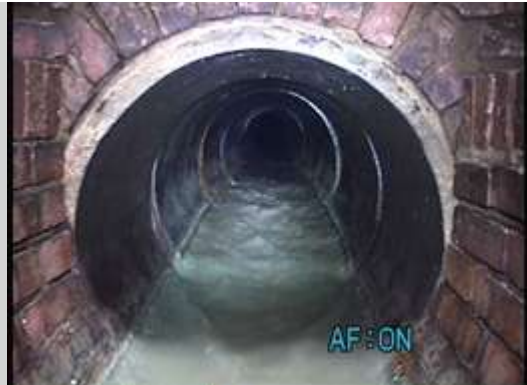
6 O'Clock Inflow

22 in. Circular Gravity Sewer
Pipe In @ 6 O'Clock

Infiltration: **None** Pipe Seal Cond: **Sound**
